Limited Hazardous Material Pre-Renovation Survey Report

Balch Hall
600 Thurston Avenue
Ithaca, New York 14850

**RE: Limited Hazardous Material Pre-Renovation Survey Report
 Balch Hall - 600 Thurston Avenue, Ithaca, New York 14850
 AECC Project Number: 18-237**

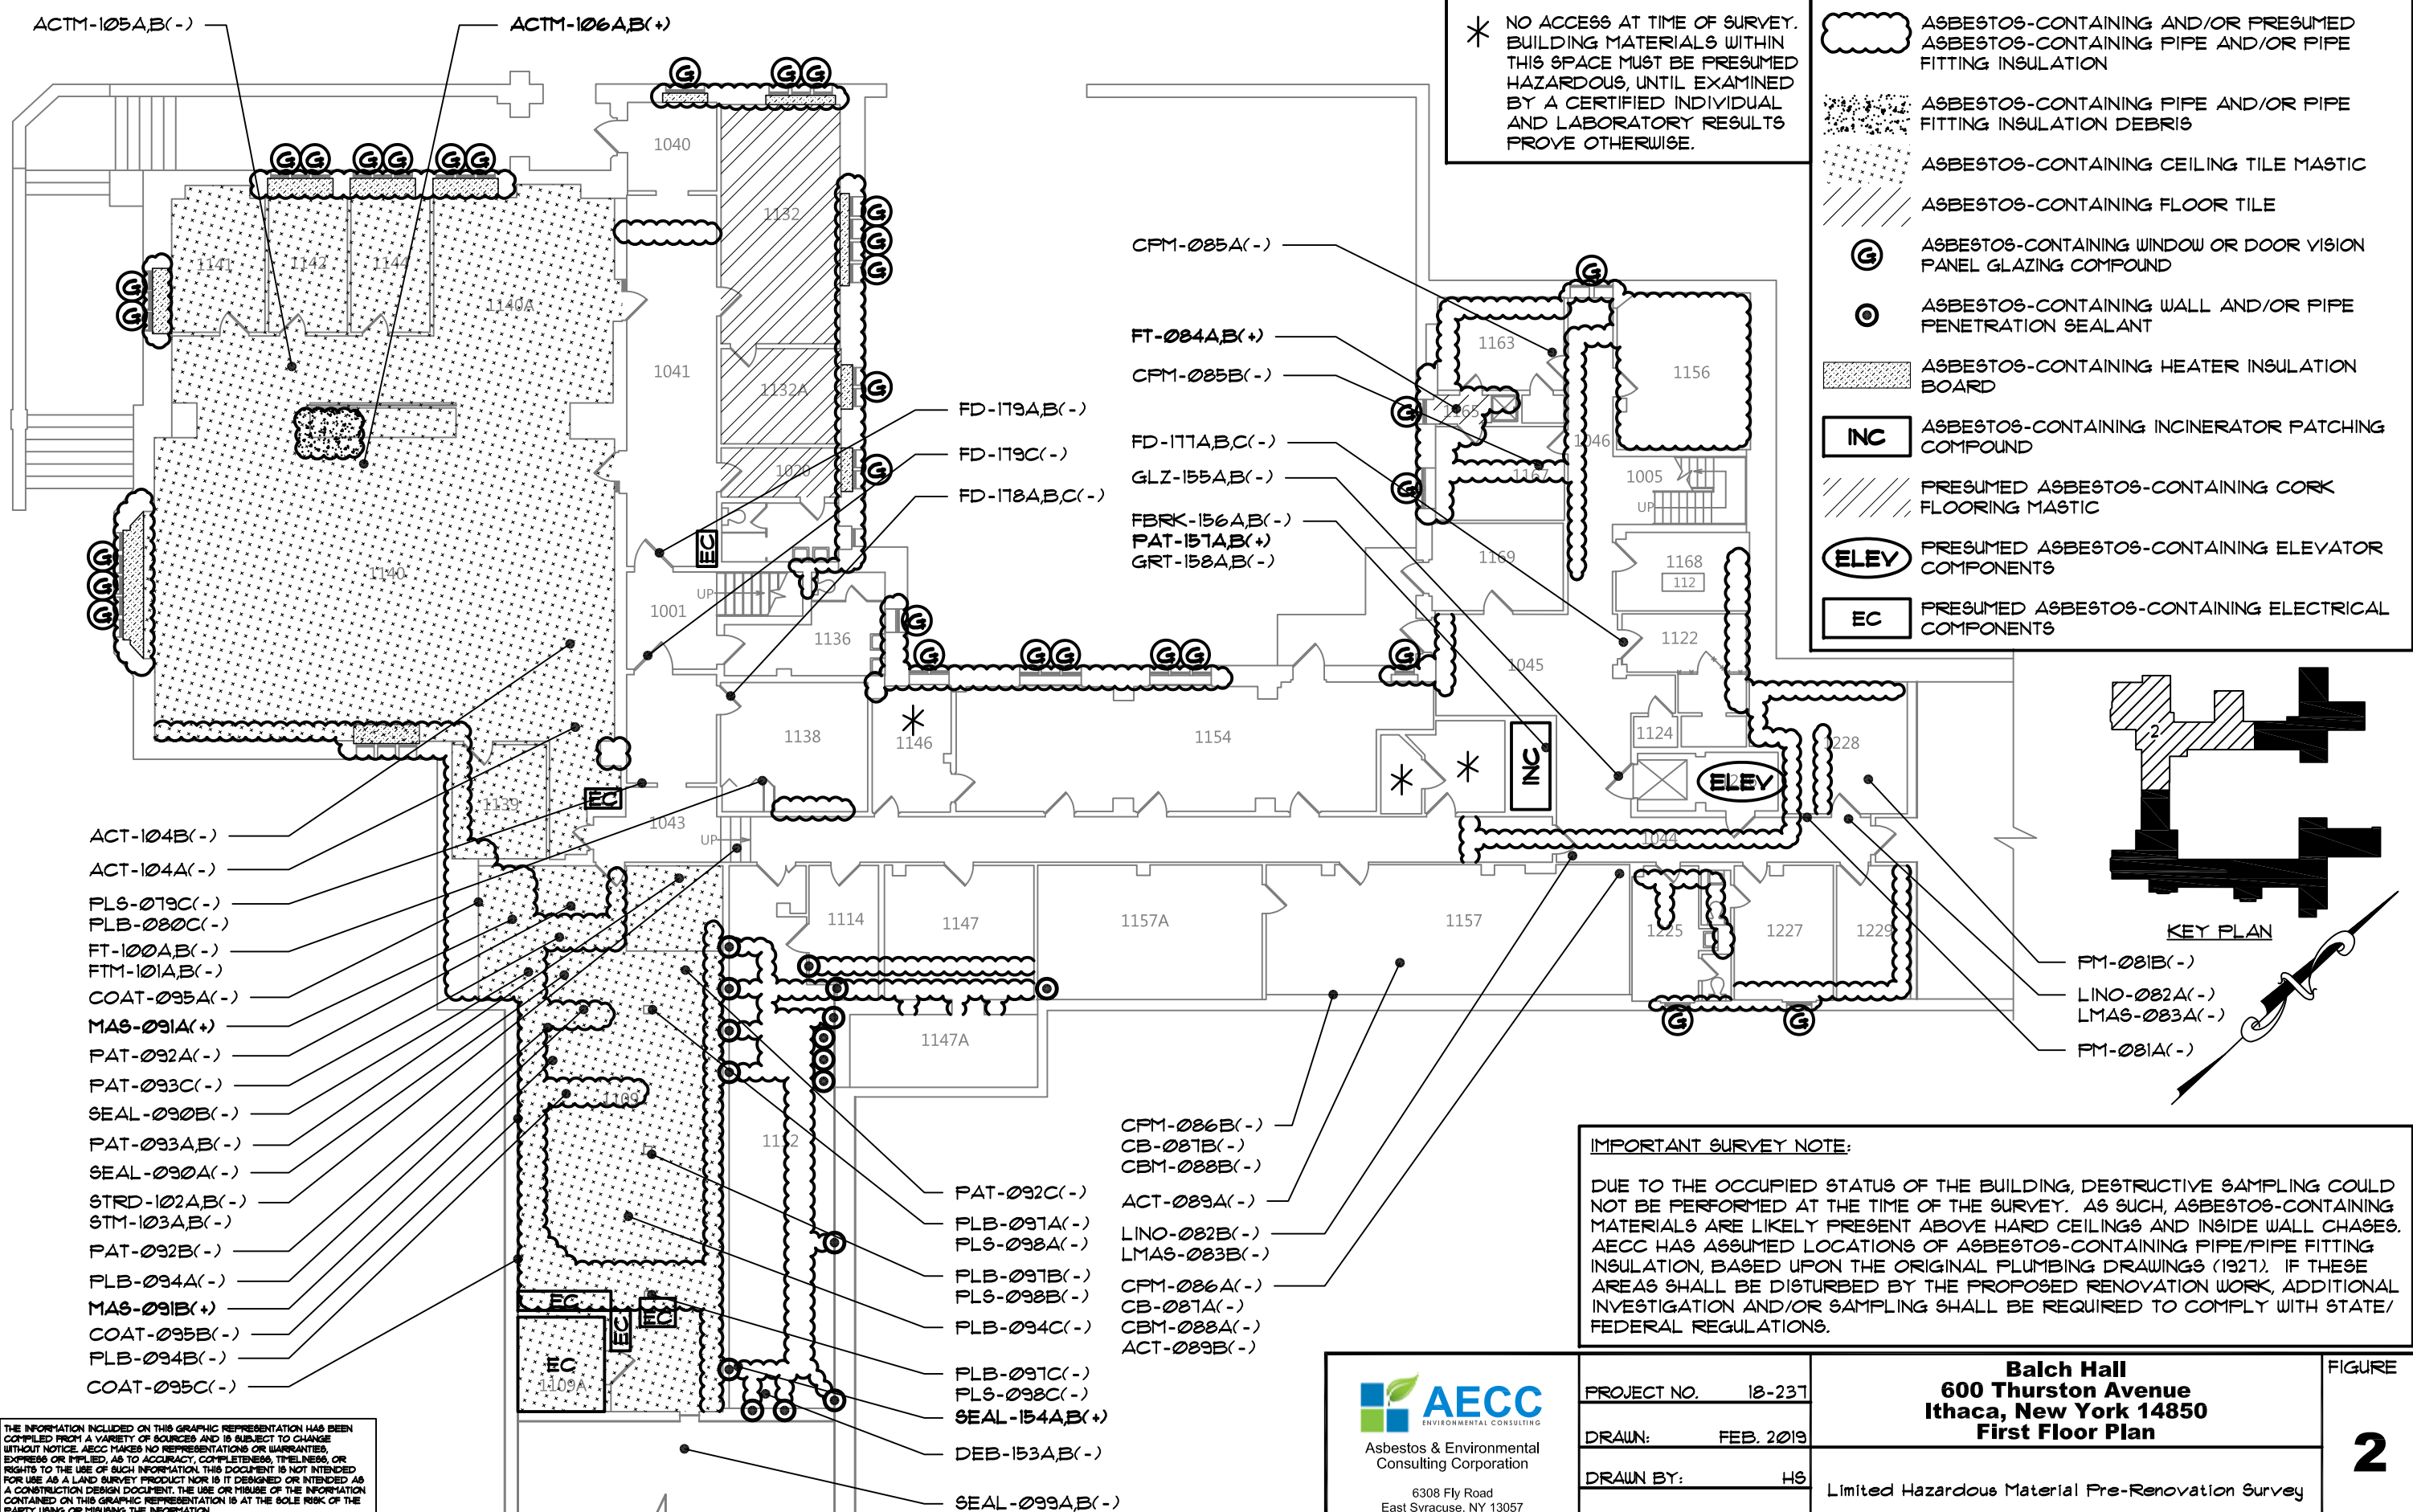
NOTE:
 * NO ACCESS AT TIME OF SURVEY. BUILDING MATERIALS WITHIN THIS SPACE MUST BE PRESUMED HAZARDOUS, UNTIL EXAMINED BY A CERTIFIED INDIVIDUAL AND LABORATORY RESULTS PROVE OTHERWISE.

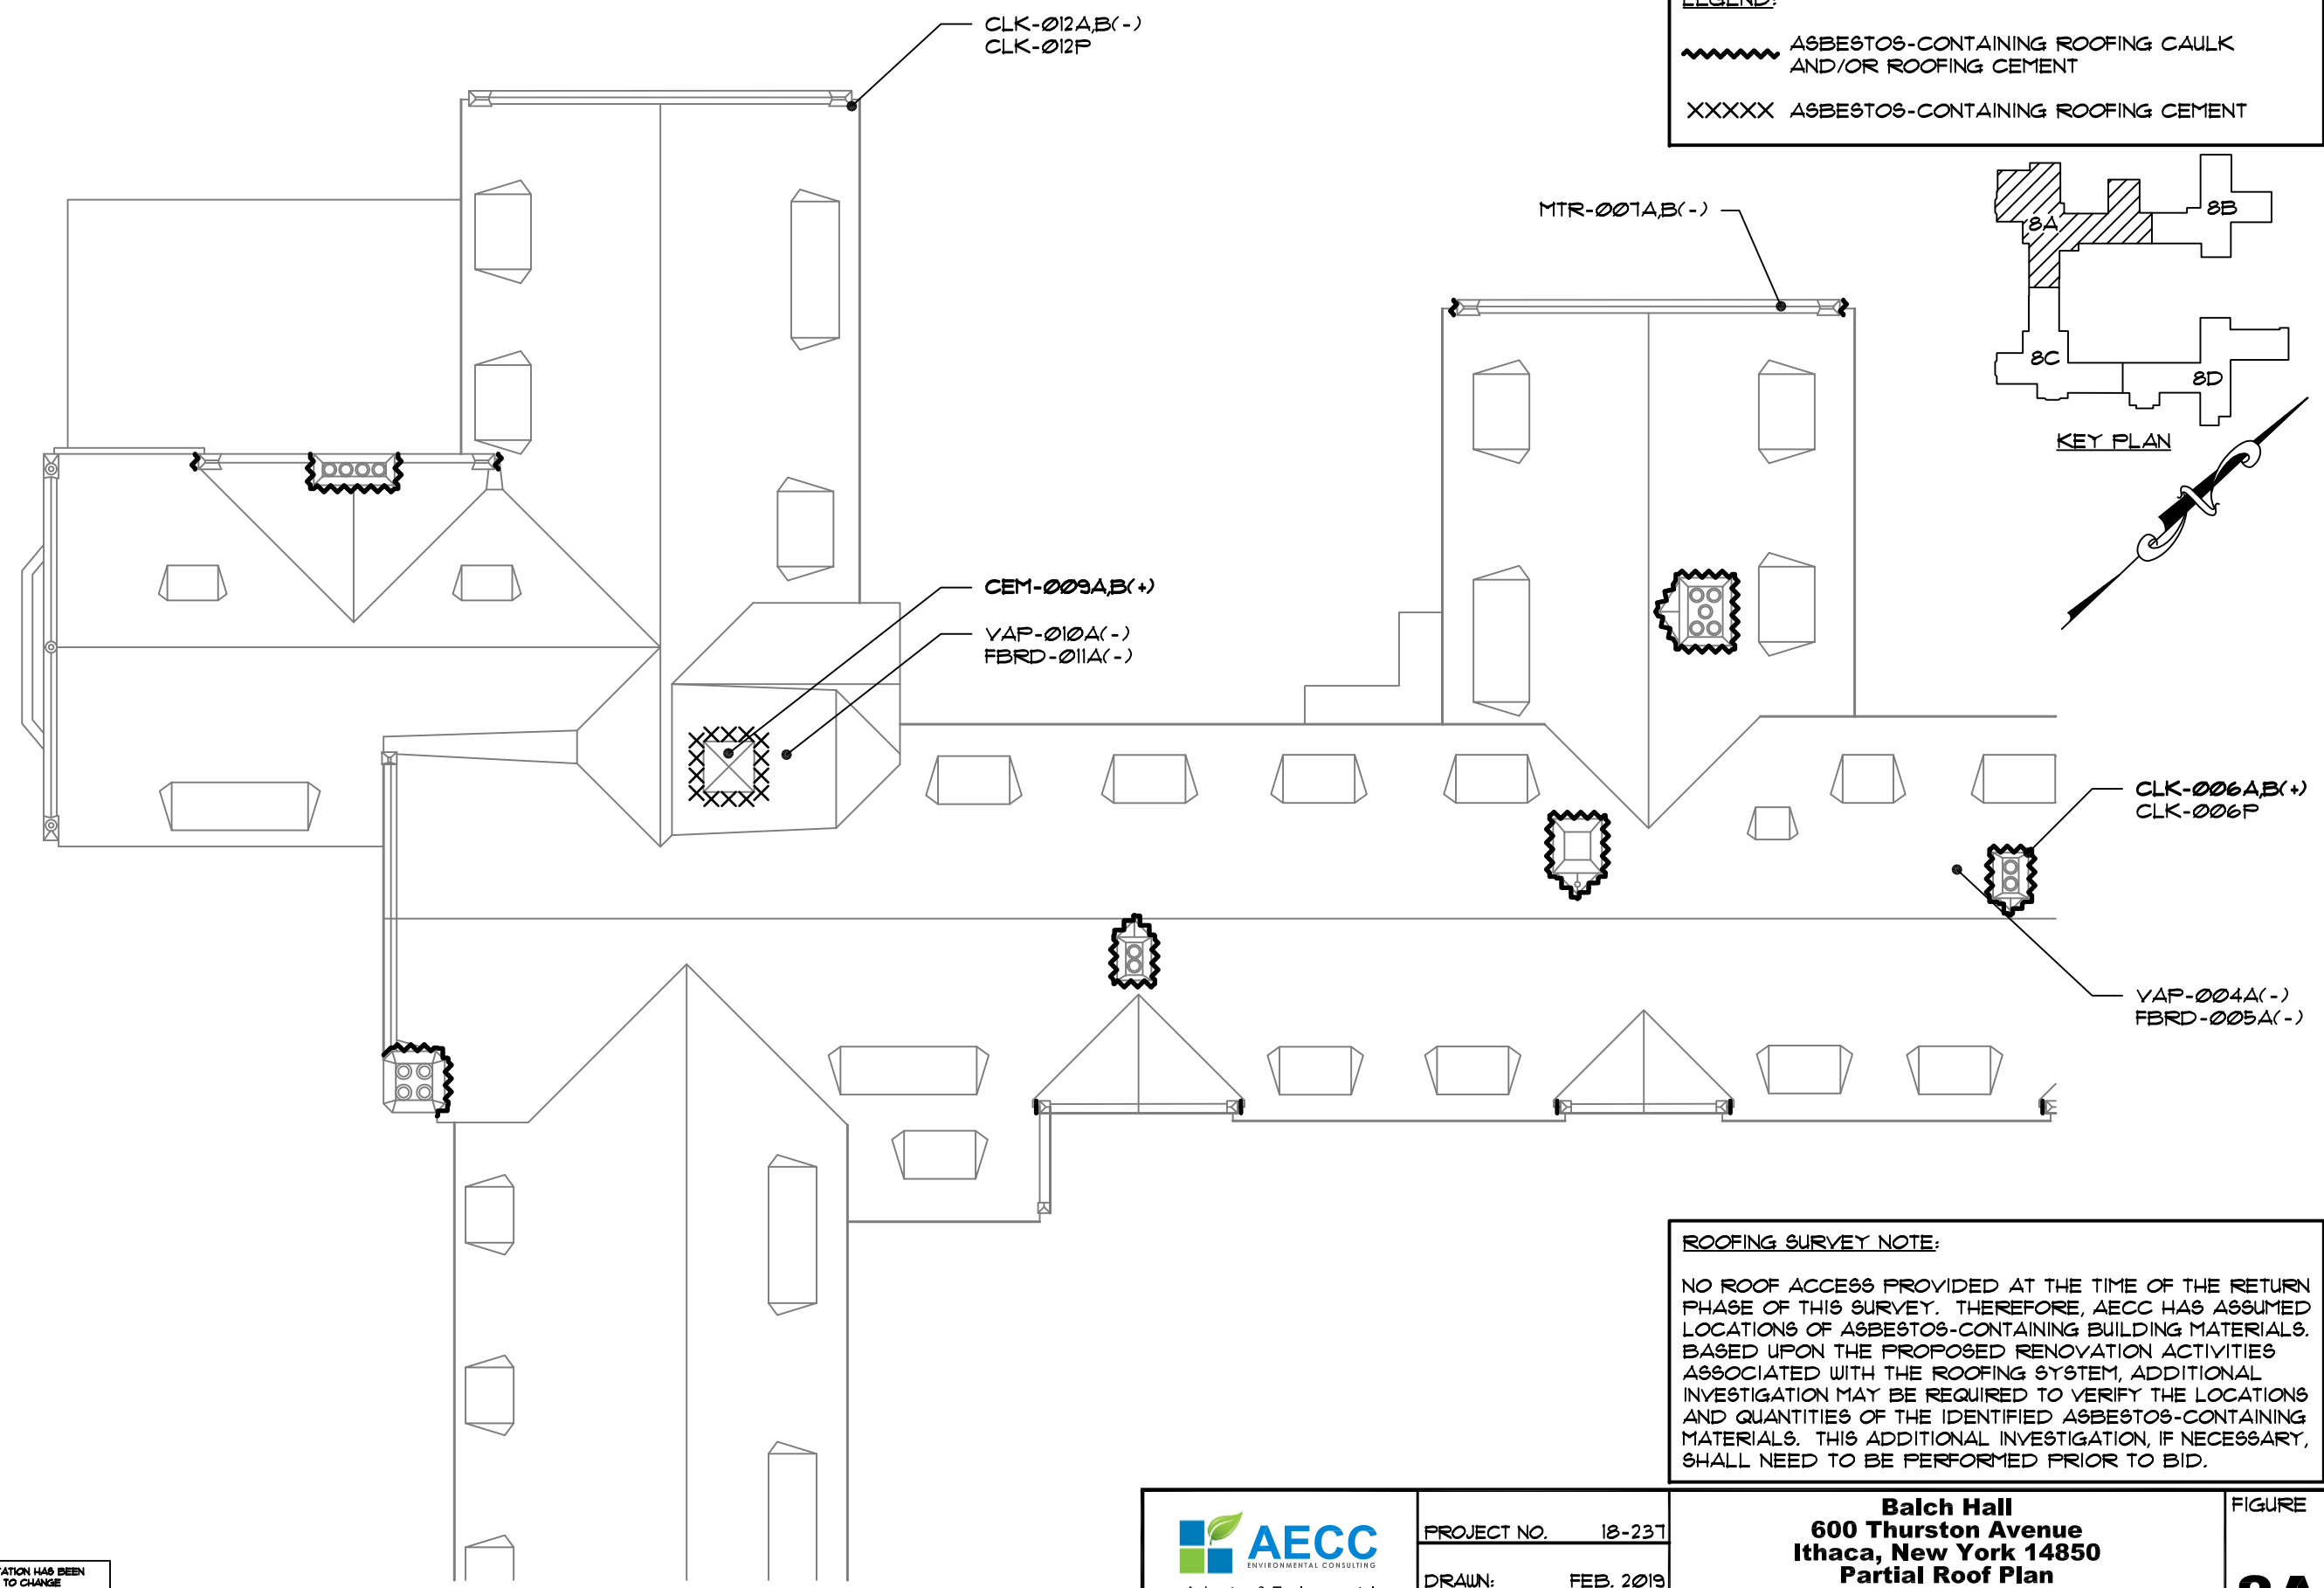
ROOFING SURVEY NOTE:
 NO ROOF ACCESS PROVIDED AT THE TIME OF THE RETURN PHASE OF THIS SURVEY. THEREFORE, AECC HAS ASSUMED LOCATIONS OF ASBESTOS-CONTAINING BUILDING MATERIALS. BASED UPON THE PROPOSED RENOVATION ACTIVITIES ASSOCIATED WITH THE ROOFING SYSTEM, ADDITIONAL INVESTIGATION MAY BE REQUIRED TO VERIFY THE LOCATIONS AND QUANTITIES OF THE IDENTIFIED ASBESTOS-CONTAINING MATERIALS. THIS ADDITIONAL INVESTIGATION, IF NECESSARY, SHALL NEED TO BE PERFORMED PRIOR TO BID.
