# Project Manual

Orvis Activity Center – Temporary Pool Infill

**Re: Alfred State Orvis Activities Center Pool SPR Scanning and Temporary Infill Recommendation Report**

**Ryan Biggs | Clark Davis Project 15408**

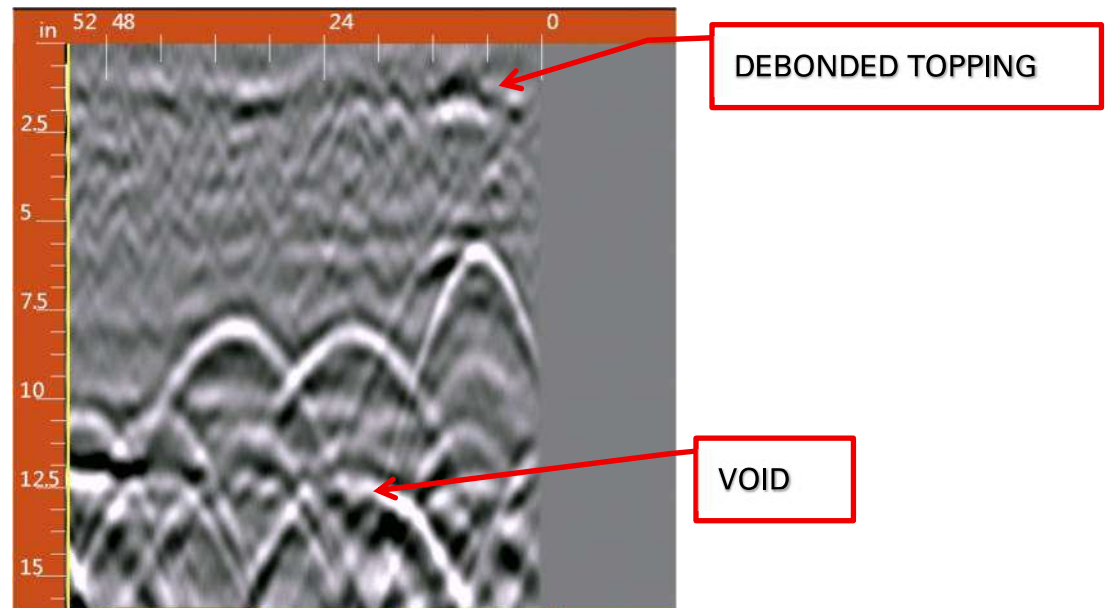
Figure 1

1. In nearly all of the scans, it appears that the thickset mortar bed for the tile has debonded from the concrete structure along the base of the pool.

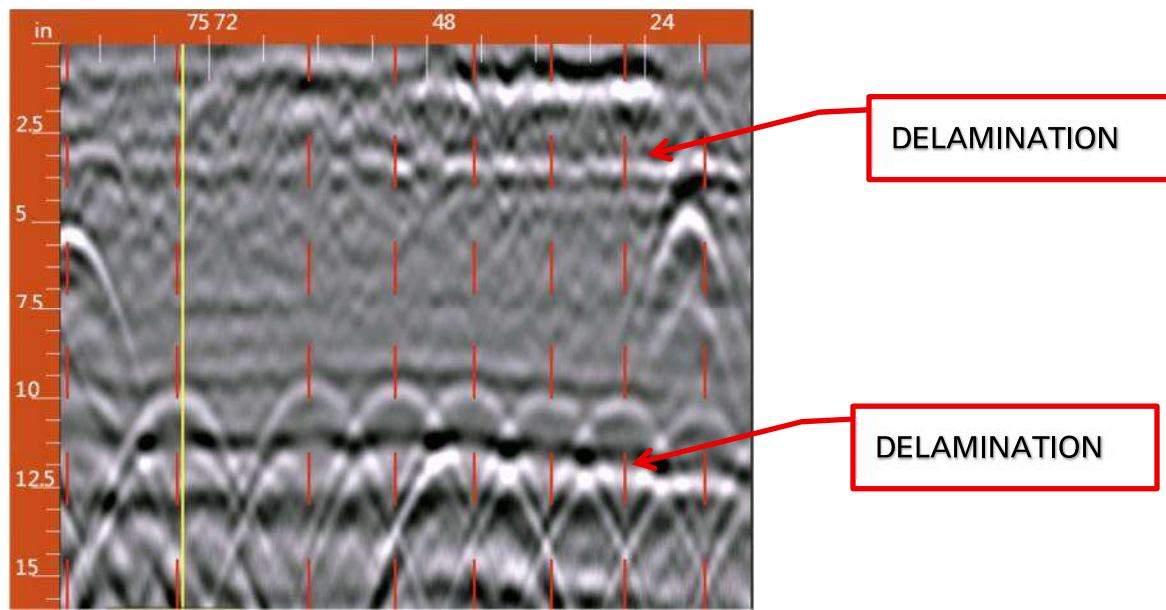
Figure 2

2. In the shallow end of the pool, minor voids were observed under the slab in areas on both the east and west sides of the pool. The areas are identified in green on the attached plan.

3. Along the west side of the pool, voids and possible delamination's near the bottom of the slab under the reinforcement were observed down the sloped portion of the pool and in the deep end. These areas are identified in blue on the attached plan.
4. At the pool walls, there was no indication of voids at any of the scanned locations.

1. The scanning of the pool slabs further indicated that there are potential voids under the slab in several areas, which would occur if the subbase was settling due to loss of fines.

2. Based on the extent of the voids under the slab, it is likely that springs and other natural sources of water have contributed to the widespread area of settlement that was observed.

Based on the observed presence of potential voids below the slab, we recommend that any infill solution be designed to minimize the load on the slab as much as possible.
