MCFADDIN BUTTRESS REPAIR
+ LEANING CHIMNEY REMOVAL

ADDENDUM NO. 1

FIELD REPORT

Field Report No. Mock-Up

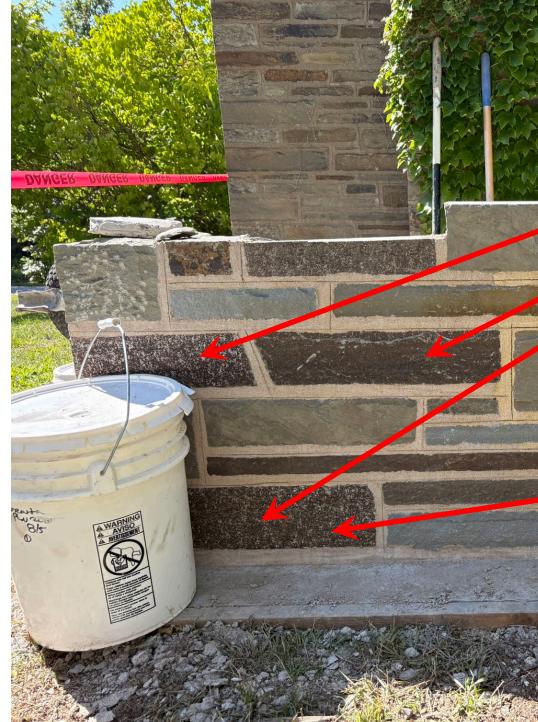
1.1	<p>The overall coloring of the stone has too much contrast with some stones appearing too dark. Acquire additional stone from quarry if necessary and build the second half of the mock-up as follows:</p> <ul style="list-style-type: none"> • Less of the darkest toned stone appearing in the wall. Coloring appears very dark brown/burgundy or even black. • More of the greens, yellows, tans, creams and rusts/reds. <p>The following was specified:</p> <p>50% Green (Seam Face) 30% Gray/Light Blue (Split Face Green) 20% Rusts, Yellows, Creams (Seam face with Mineral Deposits)</p> <p>The darkest colored stone in the mix is not described in the specifications. Some of the darker color may be acceptable but it should make up less than 5% of the wall.</p> <p>If the pallet shipped did not meet the specified percentages, it needs to be understood if the specifications are able to be met by the quarry. (*See note from 12/10/25)</p>	<p>Alliance to discuss color blend with quarry and try to get additional stone for second half of mock-up.</p> <p>*12/10/25 Meshoppen Quarry could not supply the full range of color. Stone from NY Quarry Indian Fields will be required.</p>

<p>Too many darker stones</p> <p>Darker stones appear to have quartz deposits these stones should be minimized.</p>

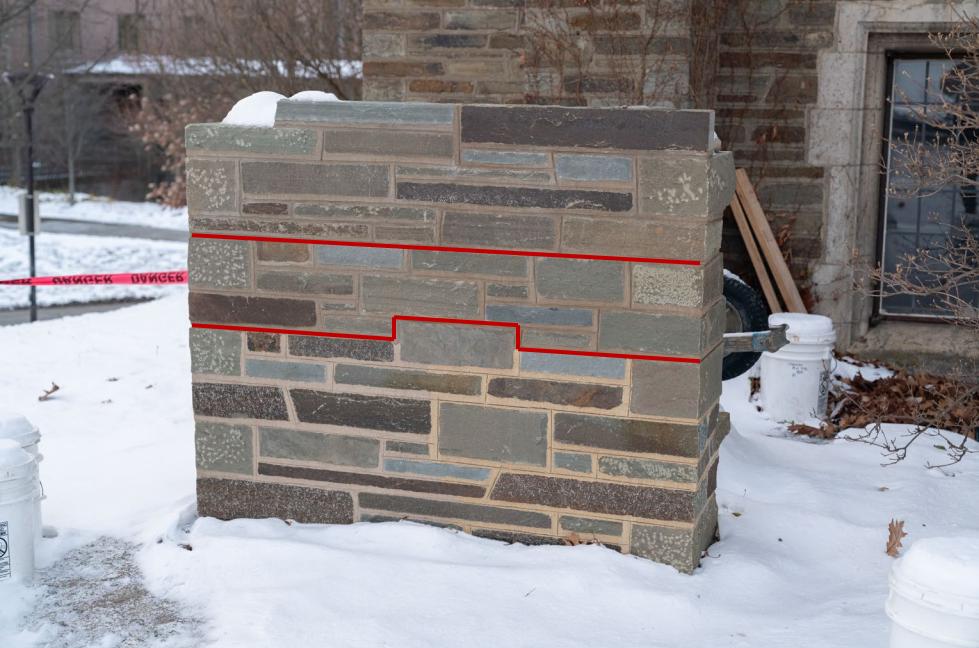
*12/10/25 Mock-Up Update

<p>*12/10/25 Mock-up completed in 2 additional stages (at red lines). Middle section does not contain the rusts, creams and yellows found on the building. The elimination of the dark stones leaves a fairly uniform gray/green coloration. The last section brings back some of the darker stones with the burgundy coloration but still does not contain the rusts and creams in the existing building. Meshoppen Quarry is unable to supply the rusts and creams. A mix of Meshoppen and NY Quarry Indian Fields Stone will be required to achieve the coloration required. All seam face quarry bedded stones can be achieved and should be successful with NY Quarry Indian Fields as it is the seam face that contains the mineral deposits with colors required for this project. It is estimated that 20% to 30% Indian Fields will be required to achieve the rusts, yellow and creams found on the buttresses at McFaddin.</p>

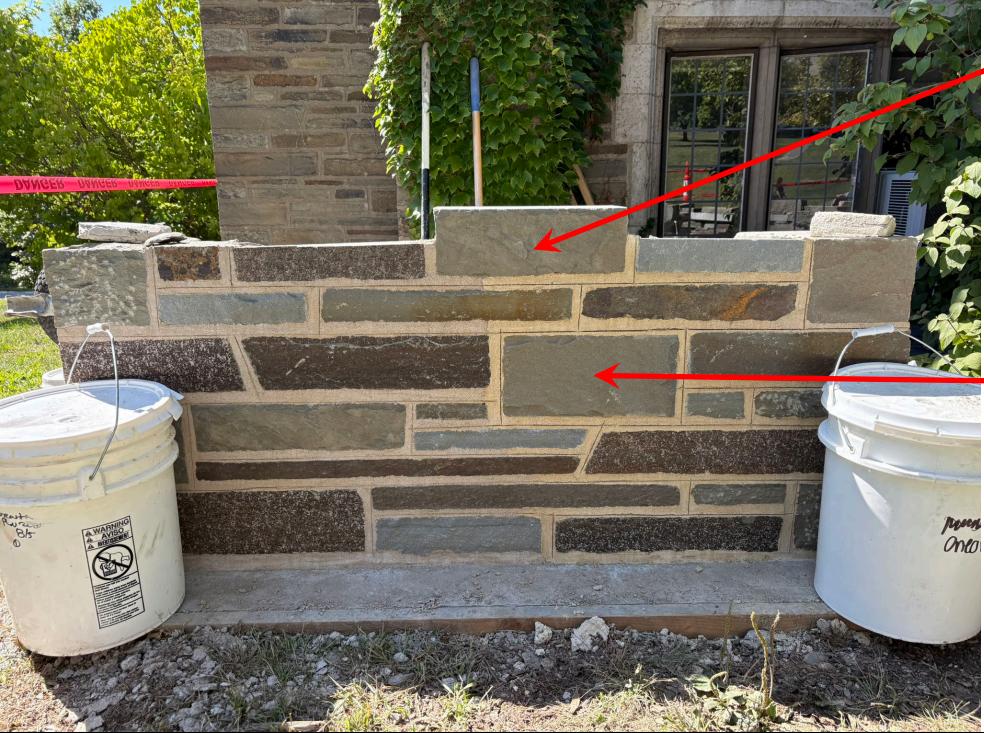
1.2	Stone Orientation	
	<p>The specifications called for all quarry bedded stones. Some stones appear to be face-bedded. It needs to be confirmed if some stones are face bedded, and if so, does it seem that some face bedded stones will be required to achieve the aesthetic intent.</p> <p>*12/10/25 Second and third mock-up stages built with all seam face quarry bedded stone.</p>	<p>Alliance to confirm if all stones can be quarry bedded. Second half of mock-up should endeavor to use all quarry bedded stone, mostly seam face.</p>

<p>Stone appears face bedded</p> <p>May not be a natural face-guillotine cut?</p>
1.3	<p>Pointing Mortar</p> <p>The pointing mortar color on the left hand side of the mock-up appears close to the original mortar color. This may need to be slightly darkened. The mortar on the right is a bit too bright and yellow.</p> <p>The mortar joint size and irregularity looks good and matches the original.</p> <p>The mortar joint profile does not match the original. The joint was scored but mortar was not removed below and to the side of the scored line to create the shadow effect apparent on McFaddin. See detail noted in mock-up drawing and existing joints on McFaddin for reference.</p>	<p>Alliance to emulate the joint profile in the second half of the mockup.</p>

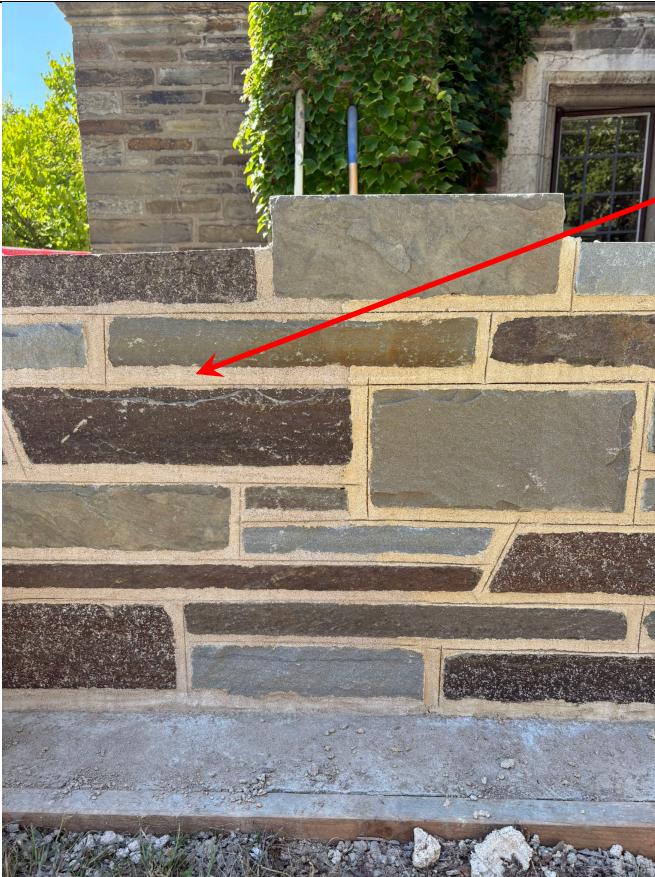
Mortar
Color
Close -
Possibly a
bit darker

Alliance to
build second
half of
mockup with
this mortar
color on half
and half with
a slightly
darker color.

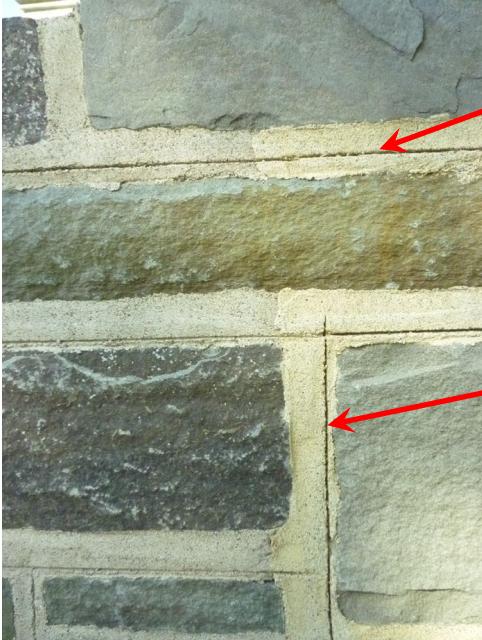
Scored line should be
slightly higher with
mortar removed from
below line to edge of
stone

Scored line should be
slightly further from edge
of stone with mortar
removed from line to
edge of stone

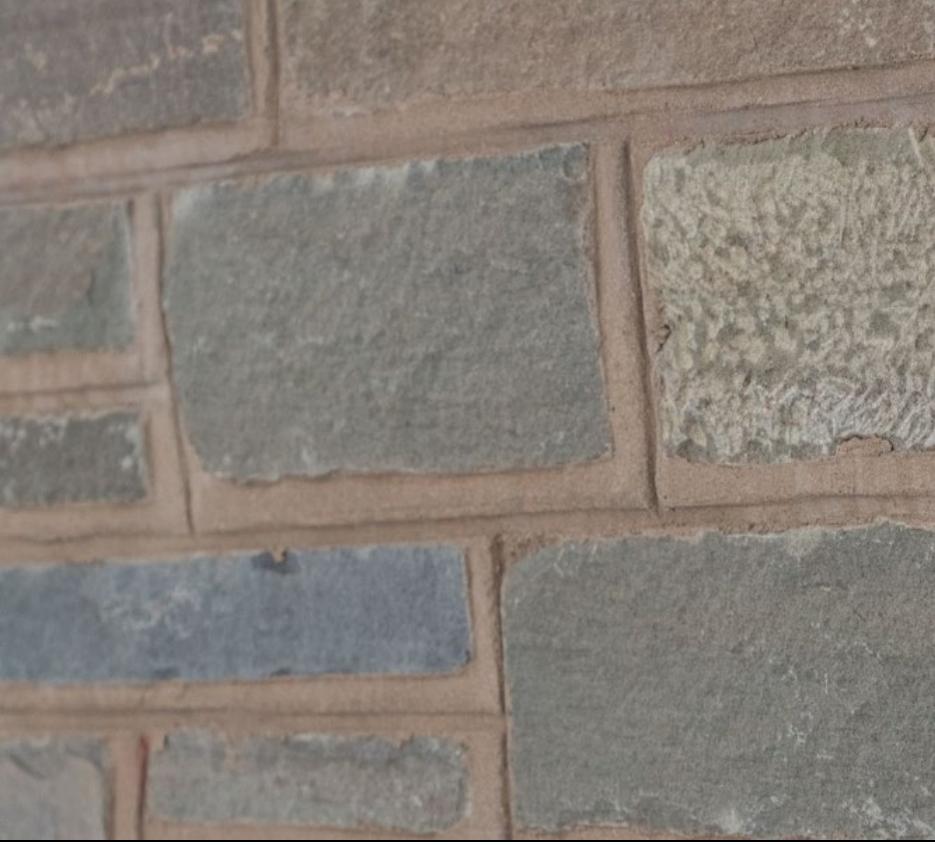
<p>*12/10/25 Color of mortar and joint technique appears very close to the original.</p>
1.4	<p>"Stippled" Corners</p> <p>The chiseled or "stippled" faces look appropriate and are well done. MCWB suggests the following for improvement: more evenly distribute stippled patterns across whole face of the stone.</p>

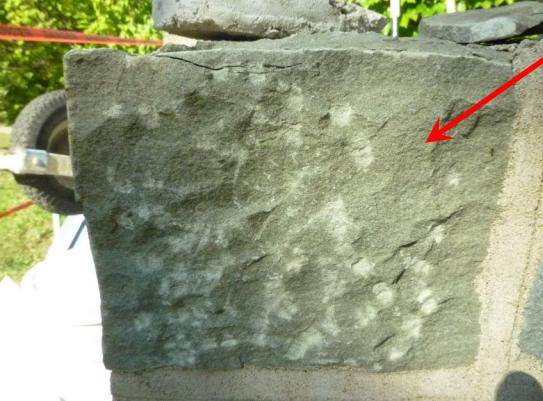
<div style="border: 2px solid red; padding: 5px; display: inline-block;"> <p>This area has no stippling</p> </div>	
	<p>Stippled face is appropriate and well done. MCWB suggests stippling could be more evenly distributed.</p>

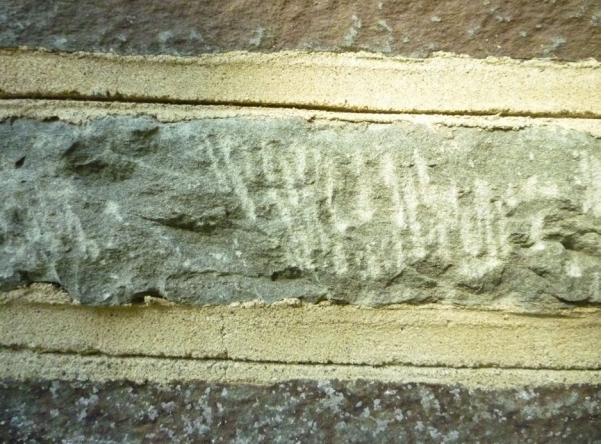
<p>"Scratch" marks not acceptable – Texture should be with "Points"</p>	
	<p>*12/10/25 Stippling technique appears more uniform in many of the stones the second and third stages fo the mock-up. See above as an example.</p>

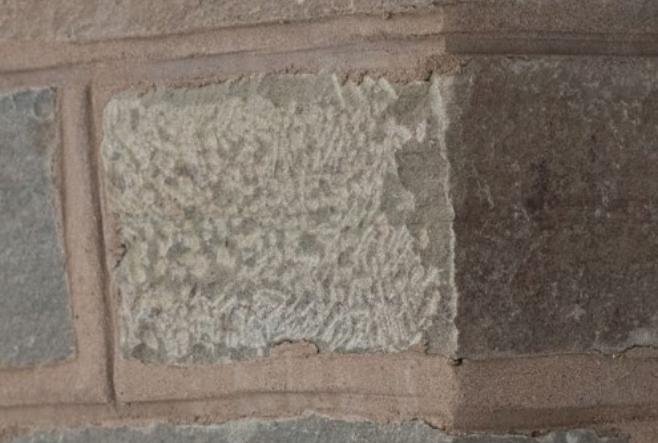
<p>*12/10/25 This stone contains more of a stippled surface texture than desired.</p>
