Limited Hazardous Material Pre-Renovation Survey Report

Balch Hall
600 Thurston Avenue
Ithaca, New York 14850

**RE: Limited Hazardous Material Pre-Renovation Survey Report
 Balch Hall - 600 Thurston Avenue, Ithaca, New York 14850
 AECC Project Number: 18-237**

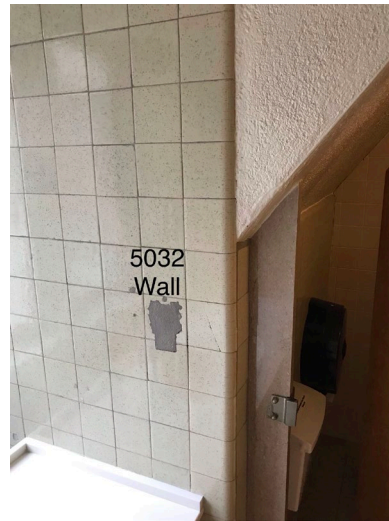
5032
Wall

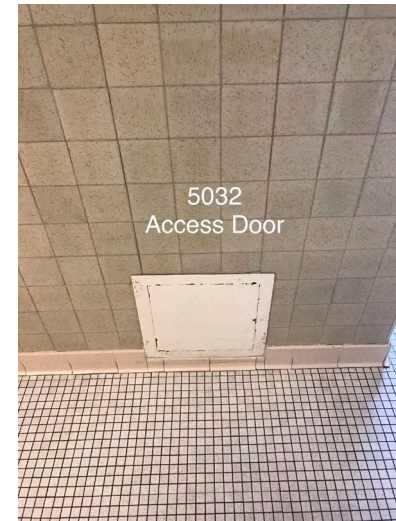
5032
Access Door

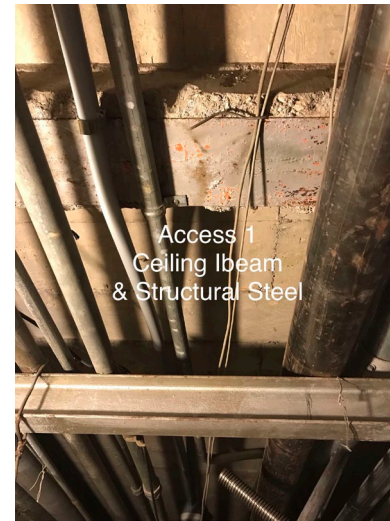
Access 1
Ceiling Ibeam
& Structural Steel

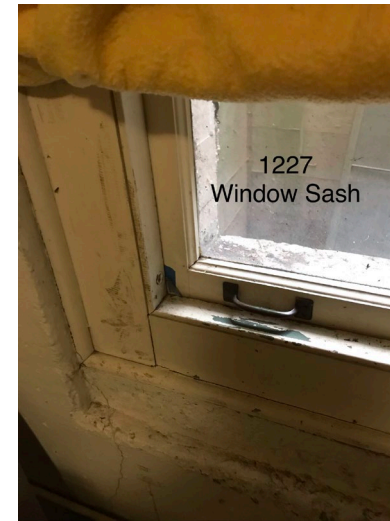
1227
Window Sash

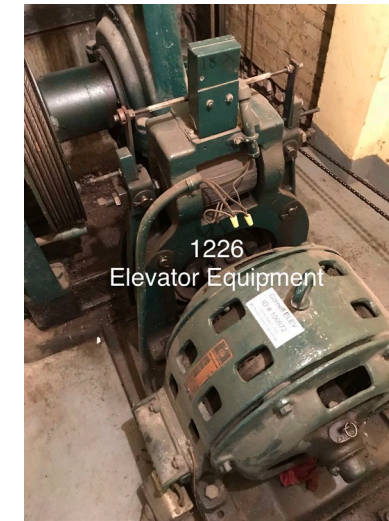
1226
Elevator Equipment

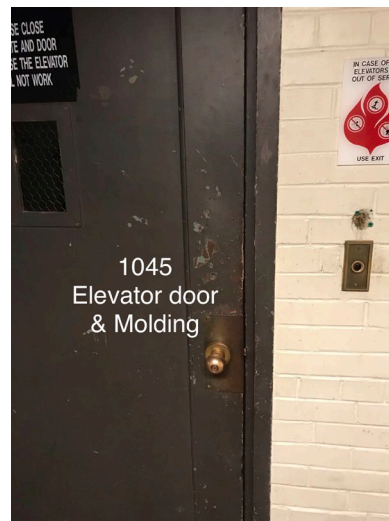
1045
Elevator door
& Molding

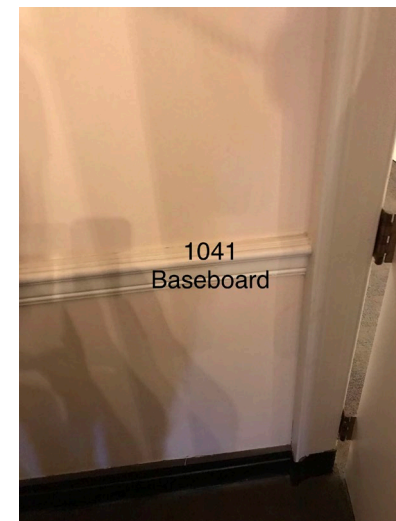
1041
Baseboard

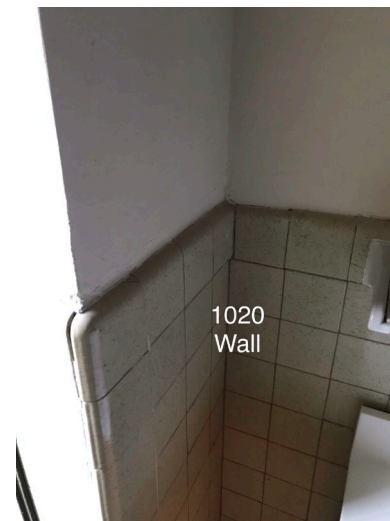
1020
Wall

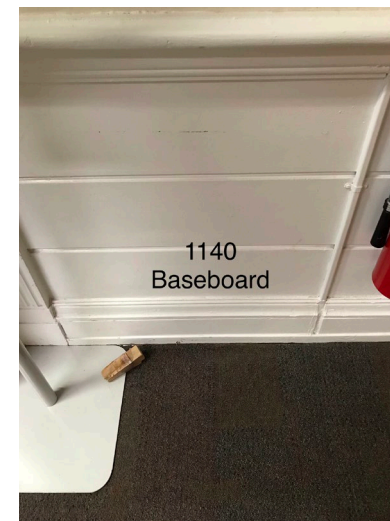
1140
Baseboard

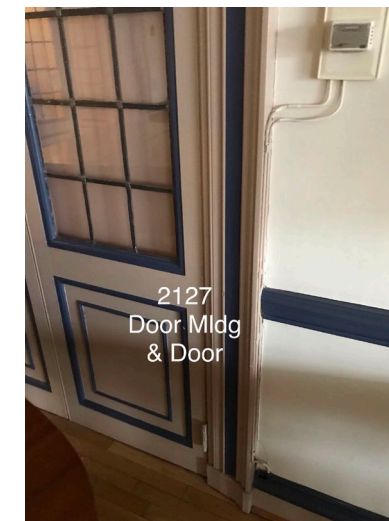
2127
Door Mldg
& Door

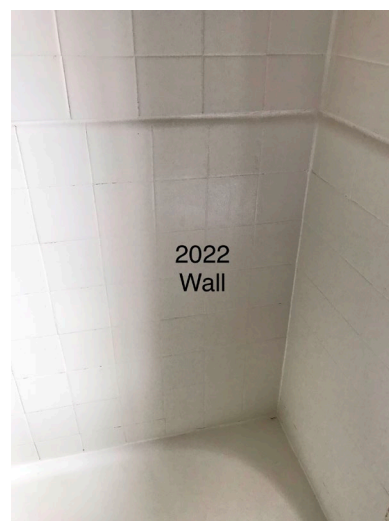
2022
Wall

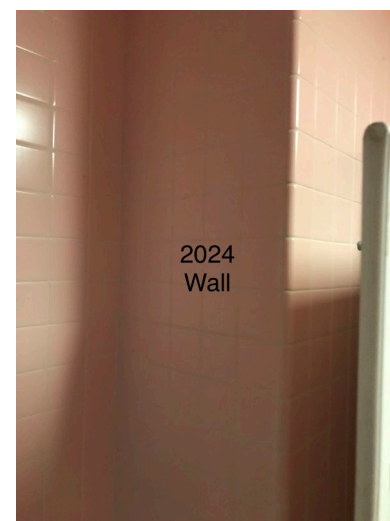
2024
Wall

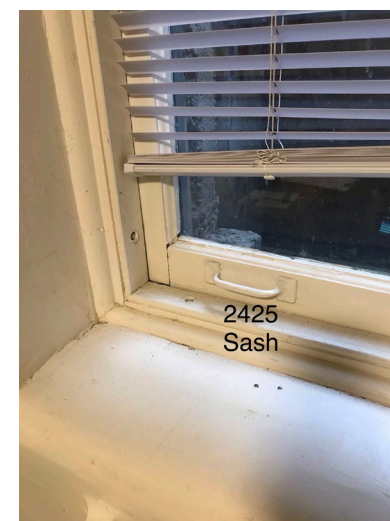
2425
Sash

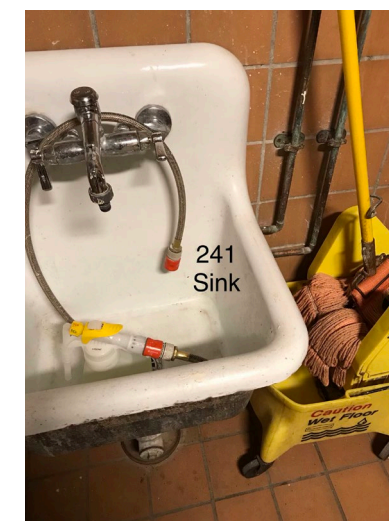
241
Sink
